# Manhole Inspection Summary

Manhole # S41G\_\_018MH

Insp Date: **5/19/08 11:14 AM**

**Location** Address: **142 lloyd st**

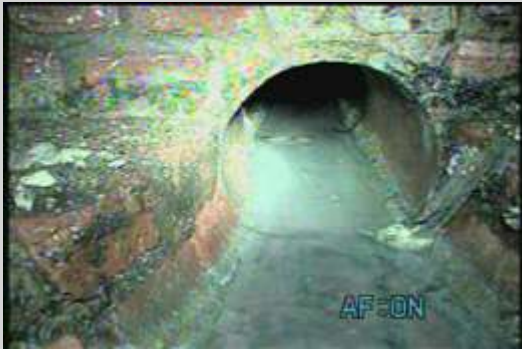
12 O'Clock Outflow

8 in. Circular Gravity Sewer  
Pipe Out @ 12 O'Clock

Pipe Material: **Clay** ☐ Pipe Lined

Invert Depth: **10.31** (ft.) Flow Characteristics: **Fast**

Deposits: ☒ None ☐ Mud ☐ Sludge ☐ Debris ☐ Grease

Infiltration: **None** Pipe Seal Cond: **Unknown**

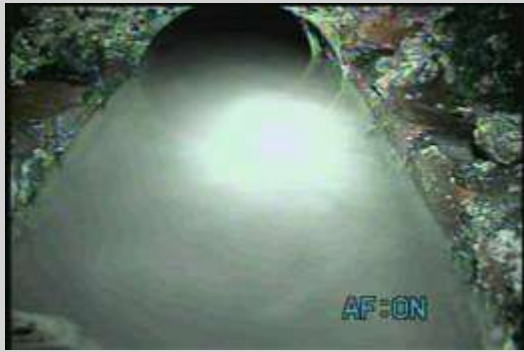
6 O'Clock Inflow

8 in. Circular Gravity Sewer

Pipe In @ 6 O'Clock

Pipe Material: **Clay** ☐ Pipe Lined

Infiltration: **None** Pipe Seal Cond: **Unknown**
